Submerged Cultural Resources Site Report

CHARLES H. SPENCER
MINING OPERATION AND
PADDLE WHEEL STEAMBOAT

GLEN CANYON NATIONAL RECREATION AREA

Southwest Cultural Resources Center Professional Papers
Number 13

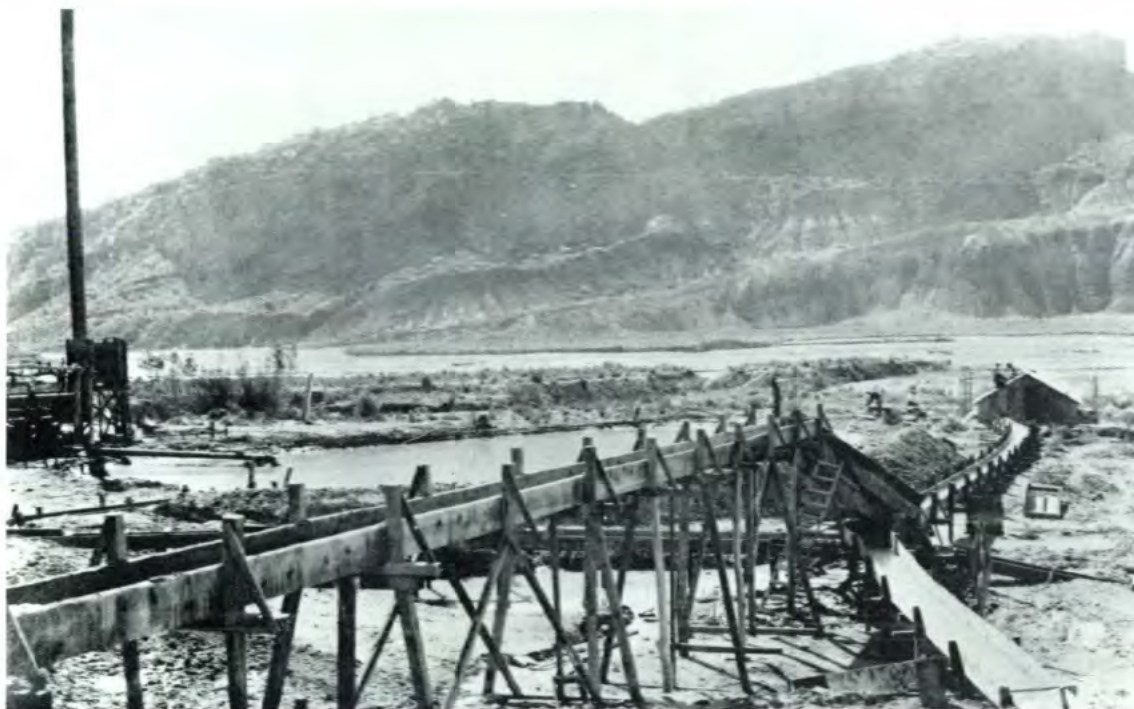
Figure 2.2. The long flume at Paria Creek, set up in late 1909 or early 1910, was used to carry the sluiced silts from the cliff to the amalgamators by the river. This arrangement was similar to the set up at Lee's Ferry. Courtesy W. L. Rusho.

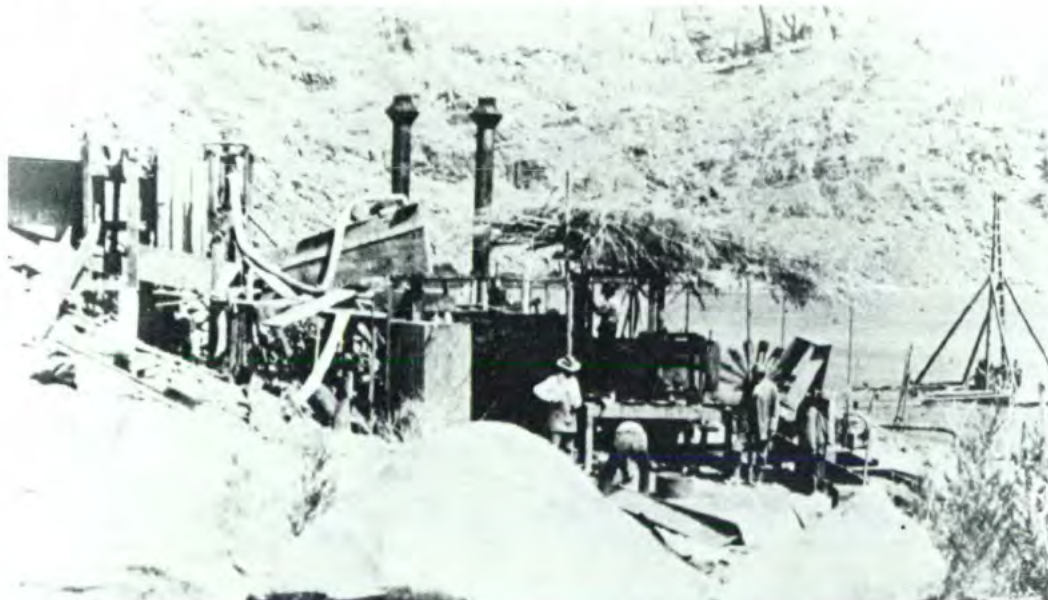
Figure 2.3. The boilers, pump, and amalgamator, set up on shore near the ramada, as well as a pipe dredge, were set up by Charles Spencer at Lee's Ferry in 1911 in an effort to extract gold from both the nearby cliffs and riverbed. National Archives Photo.

for fuel (Wilson 1961:24). A pipe dredge, a device that injected air and water under high pressure directly down into the ground forcing sand and fine particles up through a casing, was tried. The pipe dredge was set up on a gravel bed near the river bank, unfortunately just below the surface they hit coarse rock and the casing would sink no further. The experiment was given up as a failure.

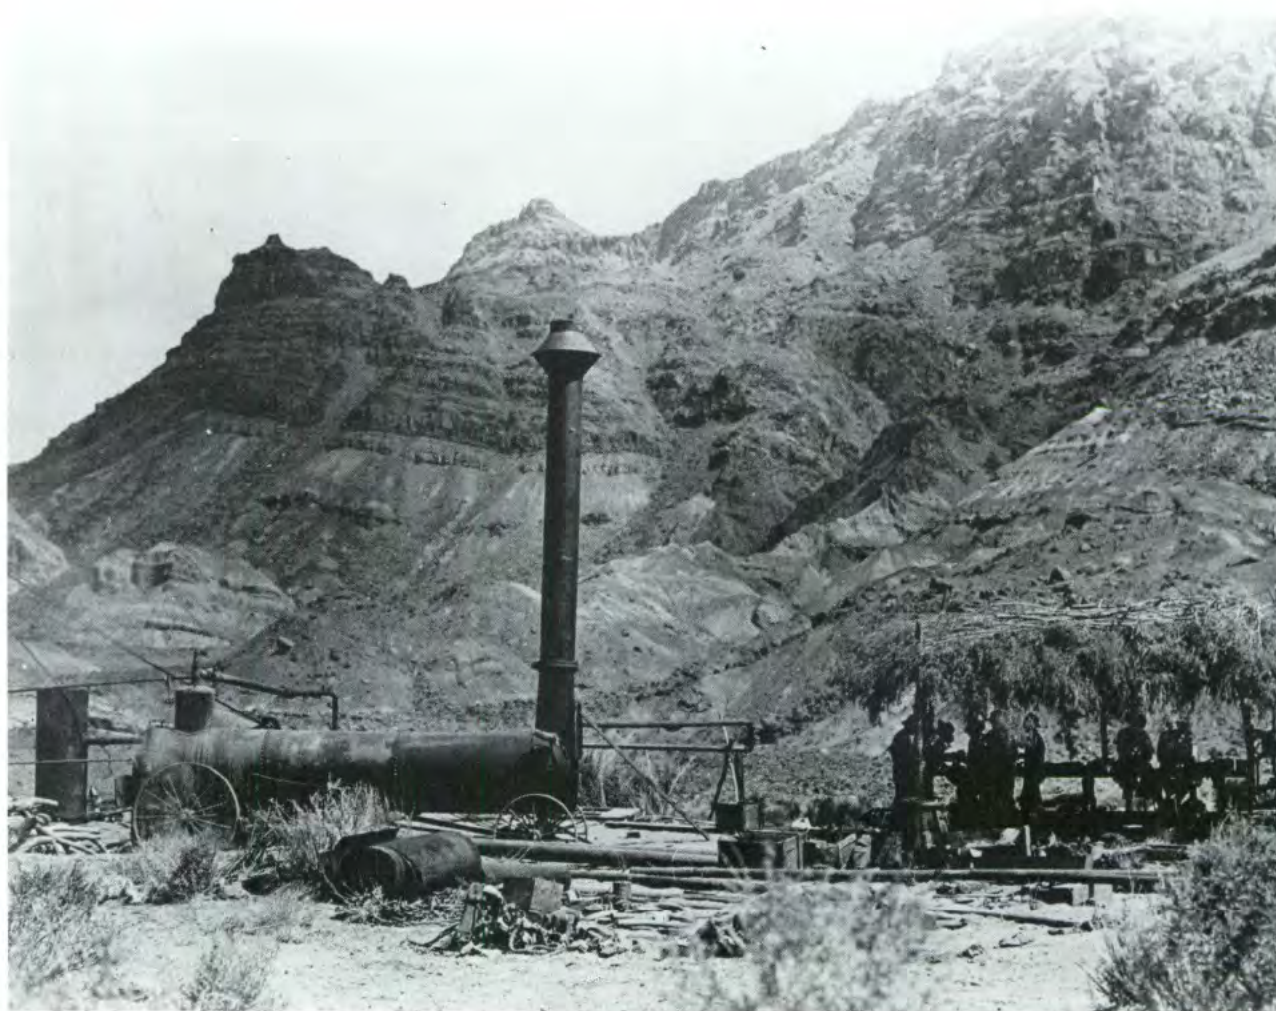
Figure 3.5. Boiler used to operate a small water pump and air compressor connected to the Lovett pipe dredge. The nozzle of the dredge can be seen extending out of the left side of the ramada. Photo by A. H. Jones, August 1910. Courtesy W. L. Rusho.

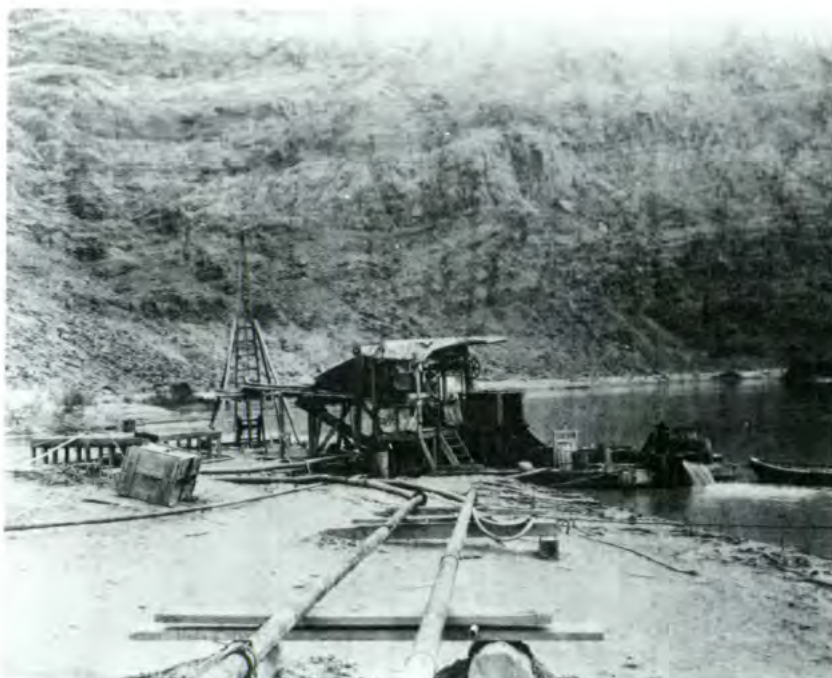
Figure 3.8. The amalgamator at Lee's Ferry. The pipes in the foreground connect the boiler/compressor to the pipe dredge in the left background. From the dredge, the discharged sand was fed to the amalgamator where efforts to extract the gold particles from the sand were carried out. Photo by Emery C. Kolb, November 1911. Special Collections Library, Northern Arizona, Northern Arizona University.

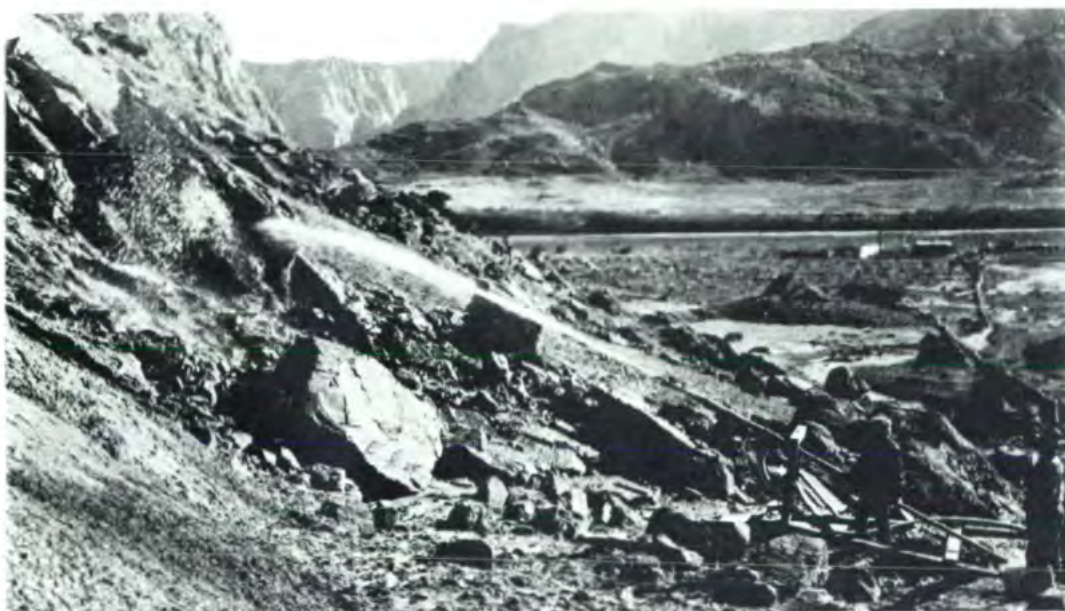
Figure 3.11. Hydraulic mining of the Chinle formation at Lee's Ferry in 1911. Water was pumped from the river, through the hose to the monitor or nozzle. The runoff was collected in a flume (right) and returned to the amalgamators at the river. Photo from Charles H. Spencer. Courtesy W. L. Rusho.

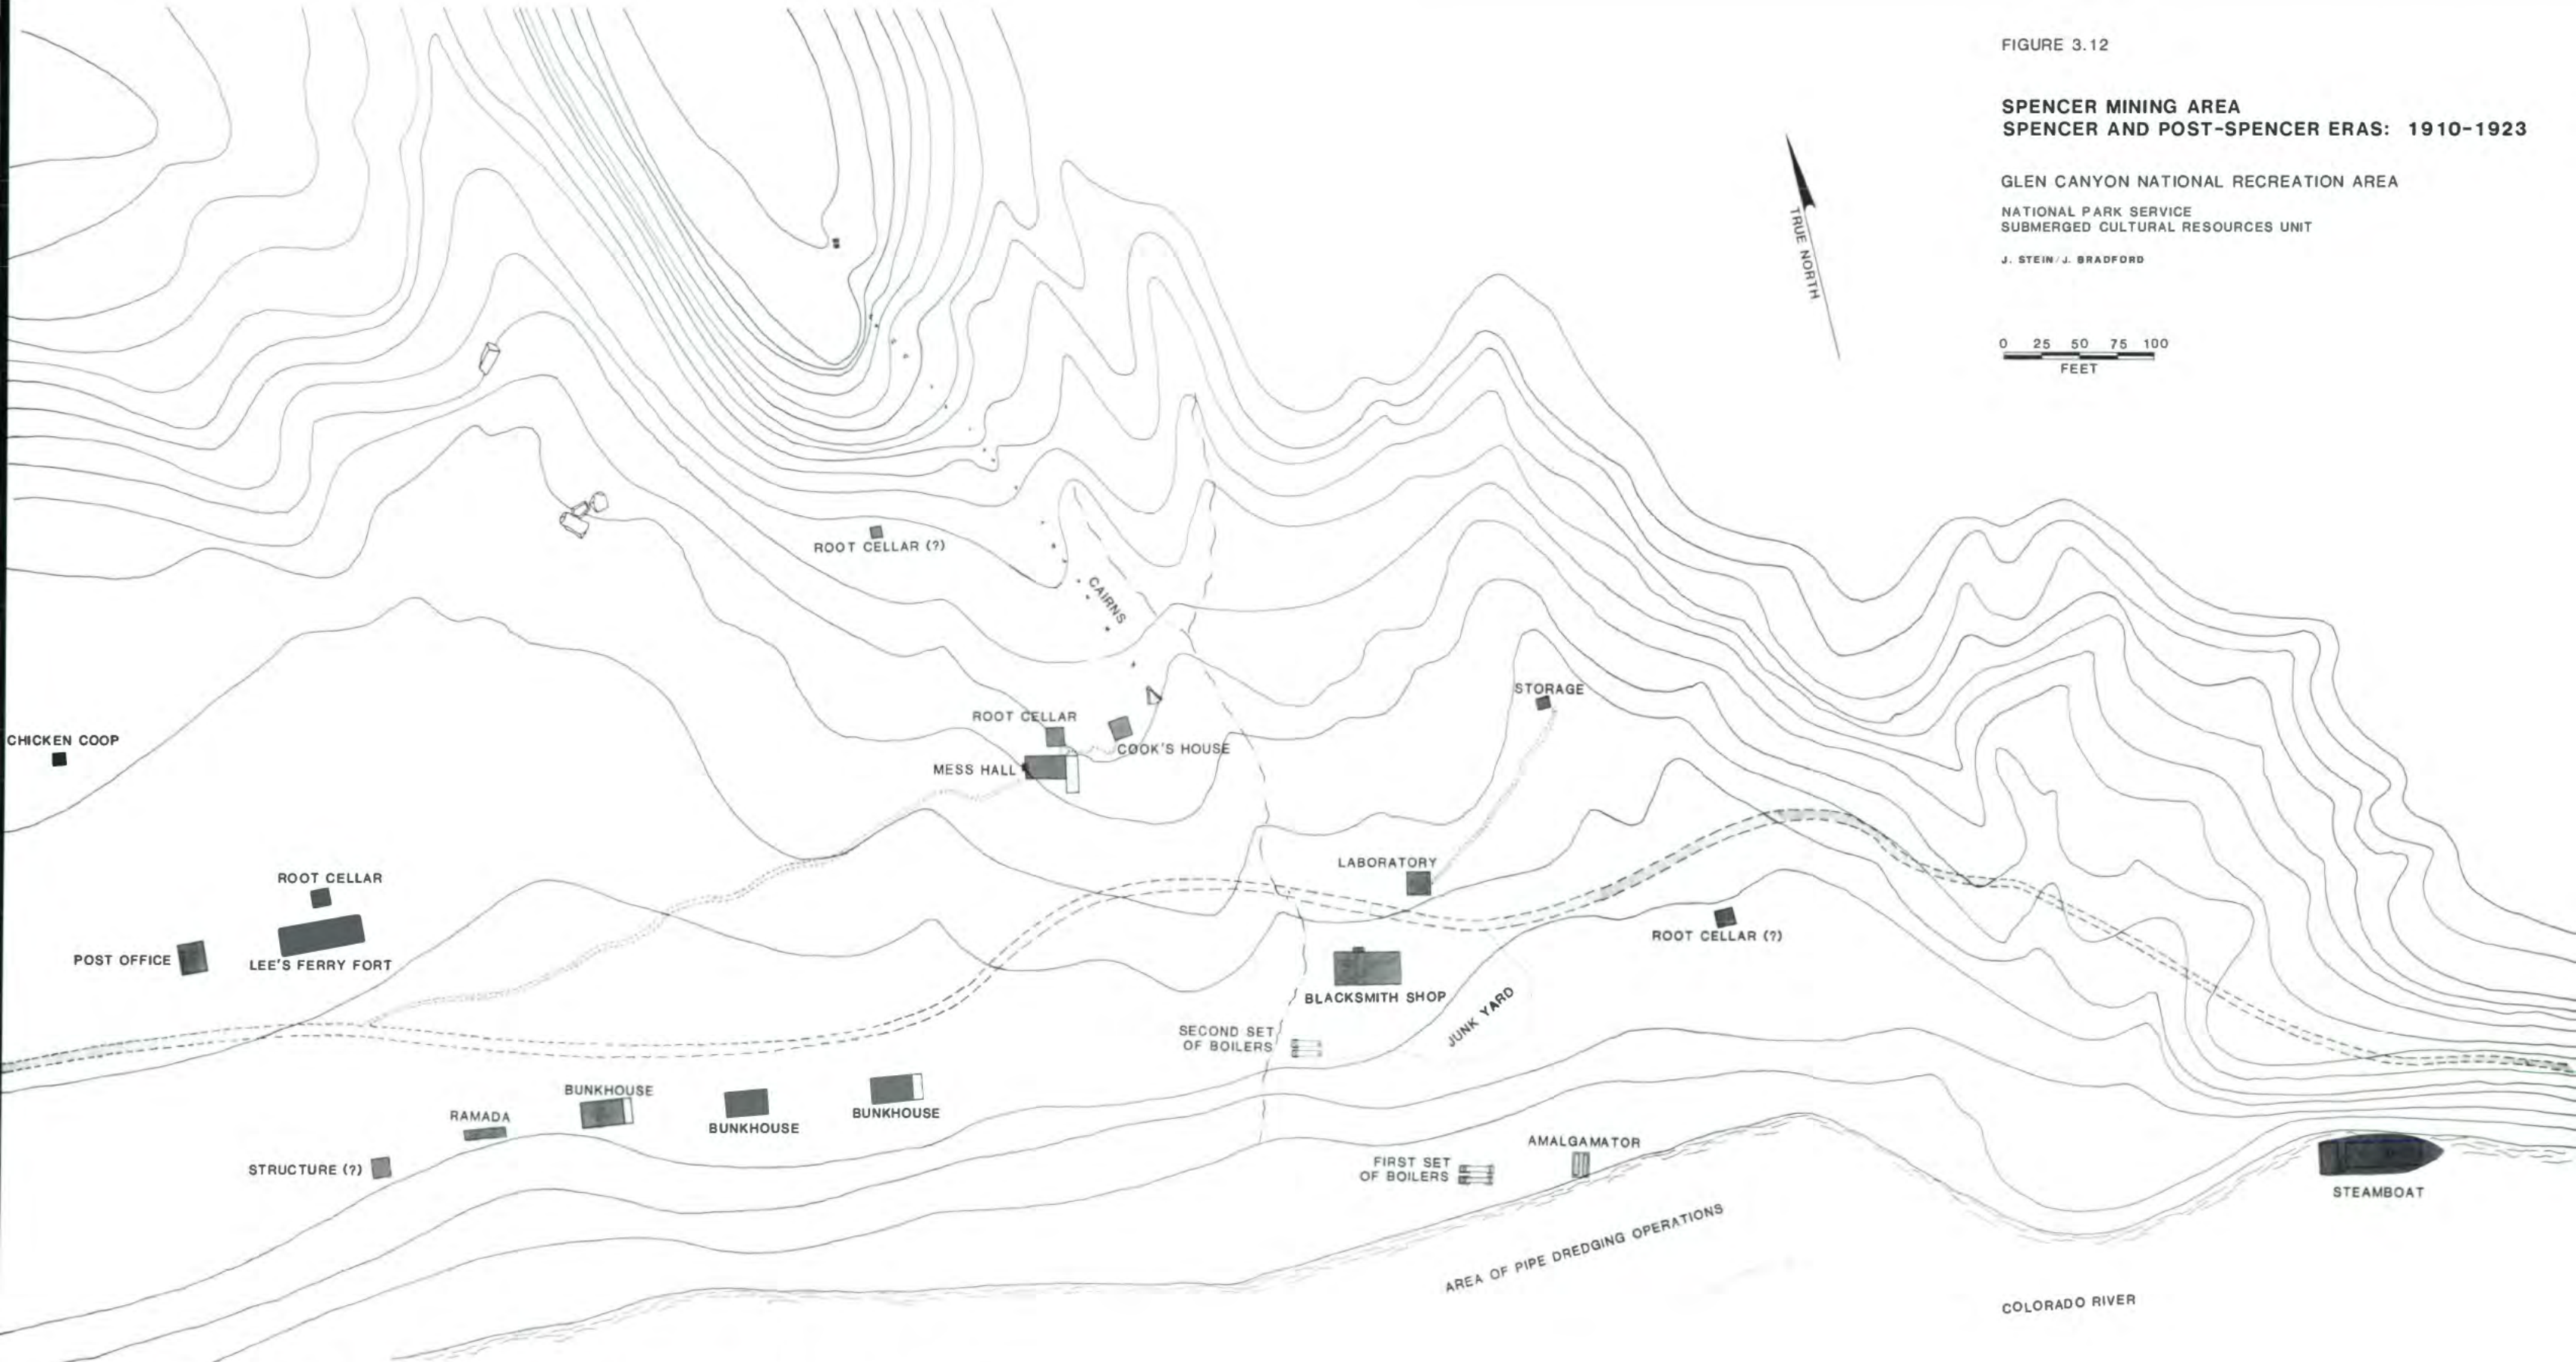
Figure 3.12. Map of the Spencer mining area depicting the location of all major features as they appeared at the end of the Spencer era and with additions from the post-Spencer decade.

The above inventory of buildings and associated features represent what still remains from Spencer's activities during the period of May 1910 to the summer of 1912 (Figure 3.12). During this time Spencer spent a considerable amount of money invested in the Chicago-based American Placer Corporation. Although the remoteness and geography of the area made mining efforts most difficult, Spencer succeeded in establishing a small community of several stone buildings and employed numerous people. As with all mining speculations in the Glen Canyon area, Spencer's was doomed to failure due to problems that the technology of the day could not overcome. Although a few men employed by Spencer stayed around Lee's Ferry and/or Paria after the operation went broke, the physical remains of the operation were, by late 1912, essentially abandoned by Spencer and left for other's use. As described by Mrs. Mary Harker who moved to Lee's Ferry in April 1913, "Spencer's mining venture had failed, and there was mining equipment all over the place, just rusting away. I remember that a steamboat was tied up along the river bank..." (Rusho 1965:1).

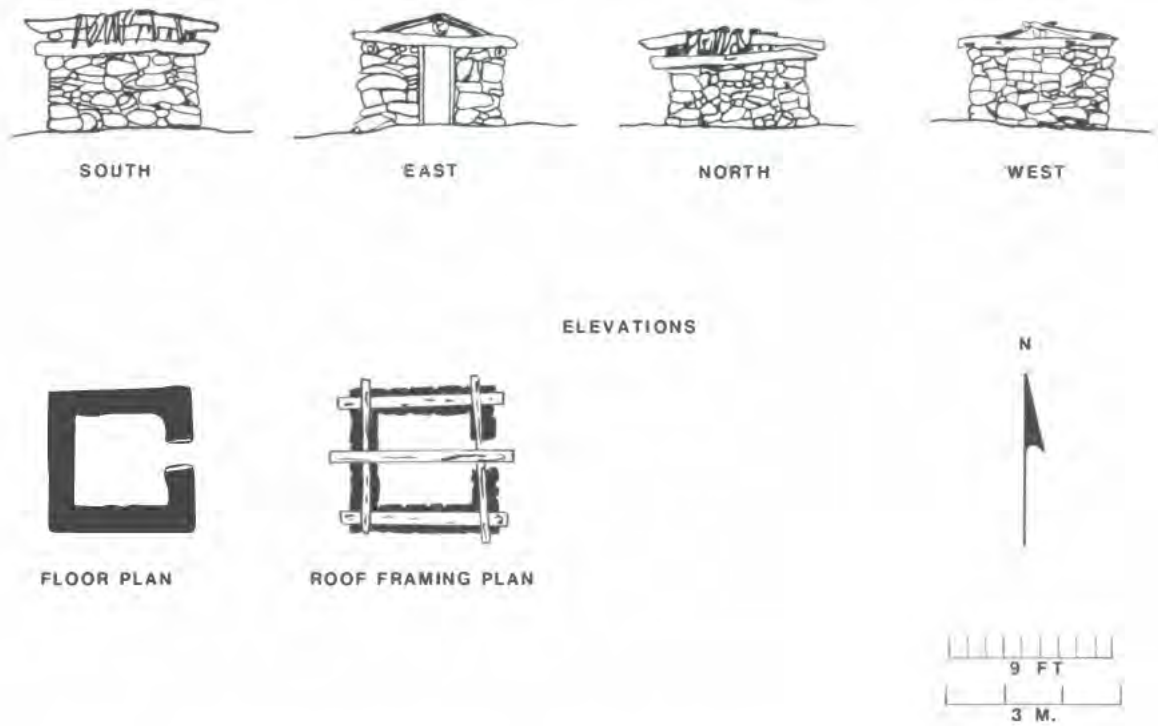
Figure 3.15. Plan and elevation drawings of the chicken coop located northwest of the fort. Adapted from Historic American Buildings Survey records.

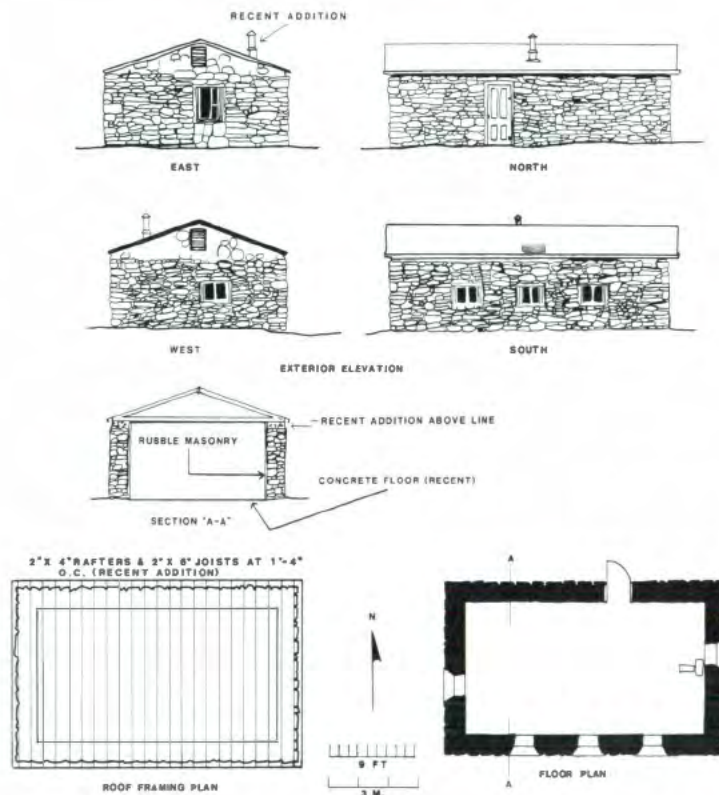
Figure 3.18. Plan and elevation drawings of Spencer's bunkhouse later remodeled into a laboratory by the USGS. Adapted from Historic American Buildings Survey records.

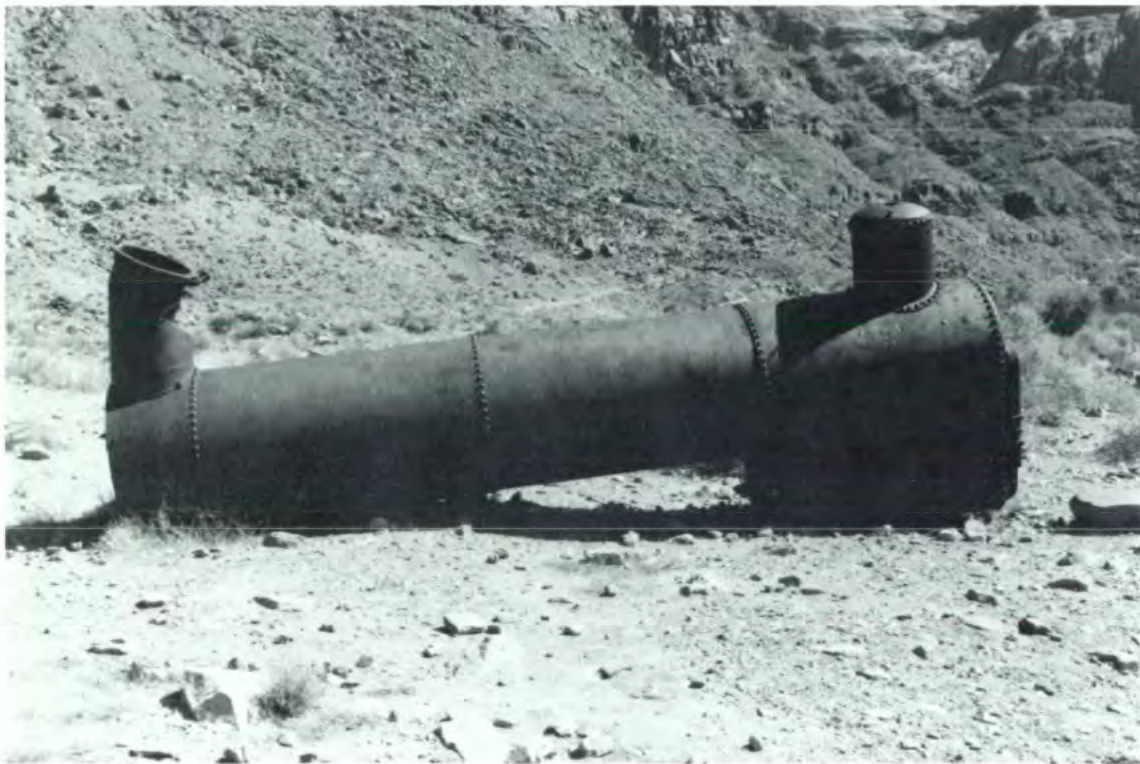
Figure 3.20. Side view of the boiler in its present condition. Photo by J. Bradford.

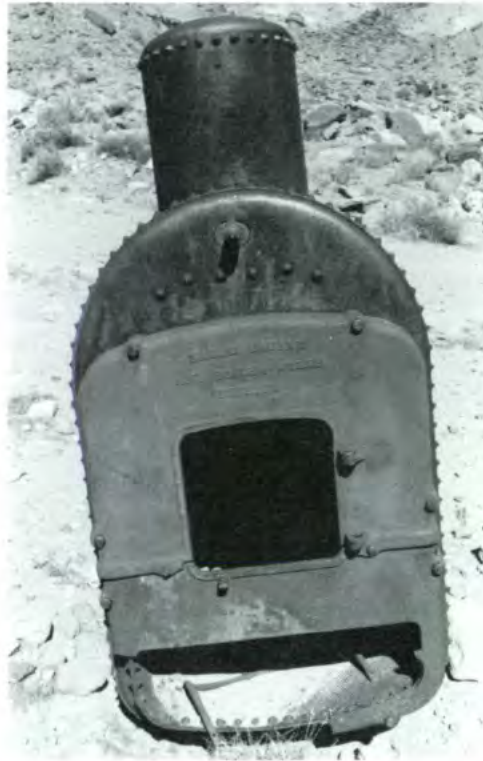
Figure 3.21. End view of the boiler showing the firebox, steam dome, and manufacturer's name. Photo by J. Bradford.

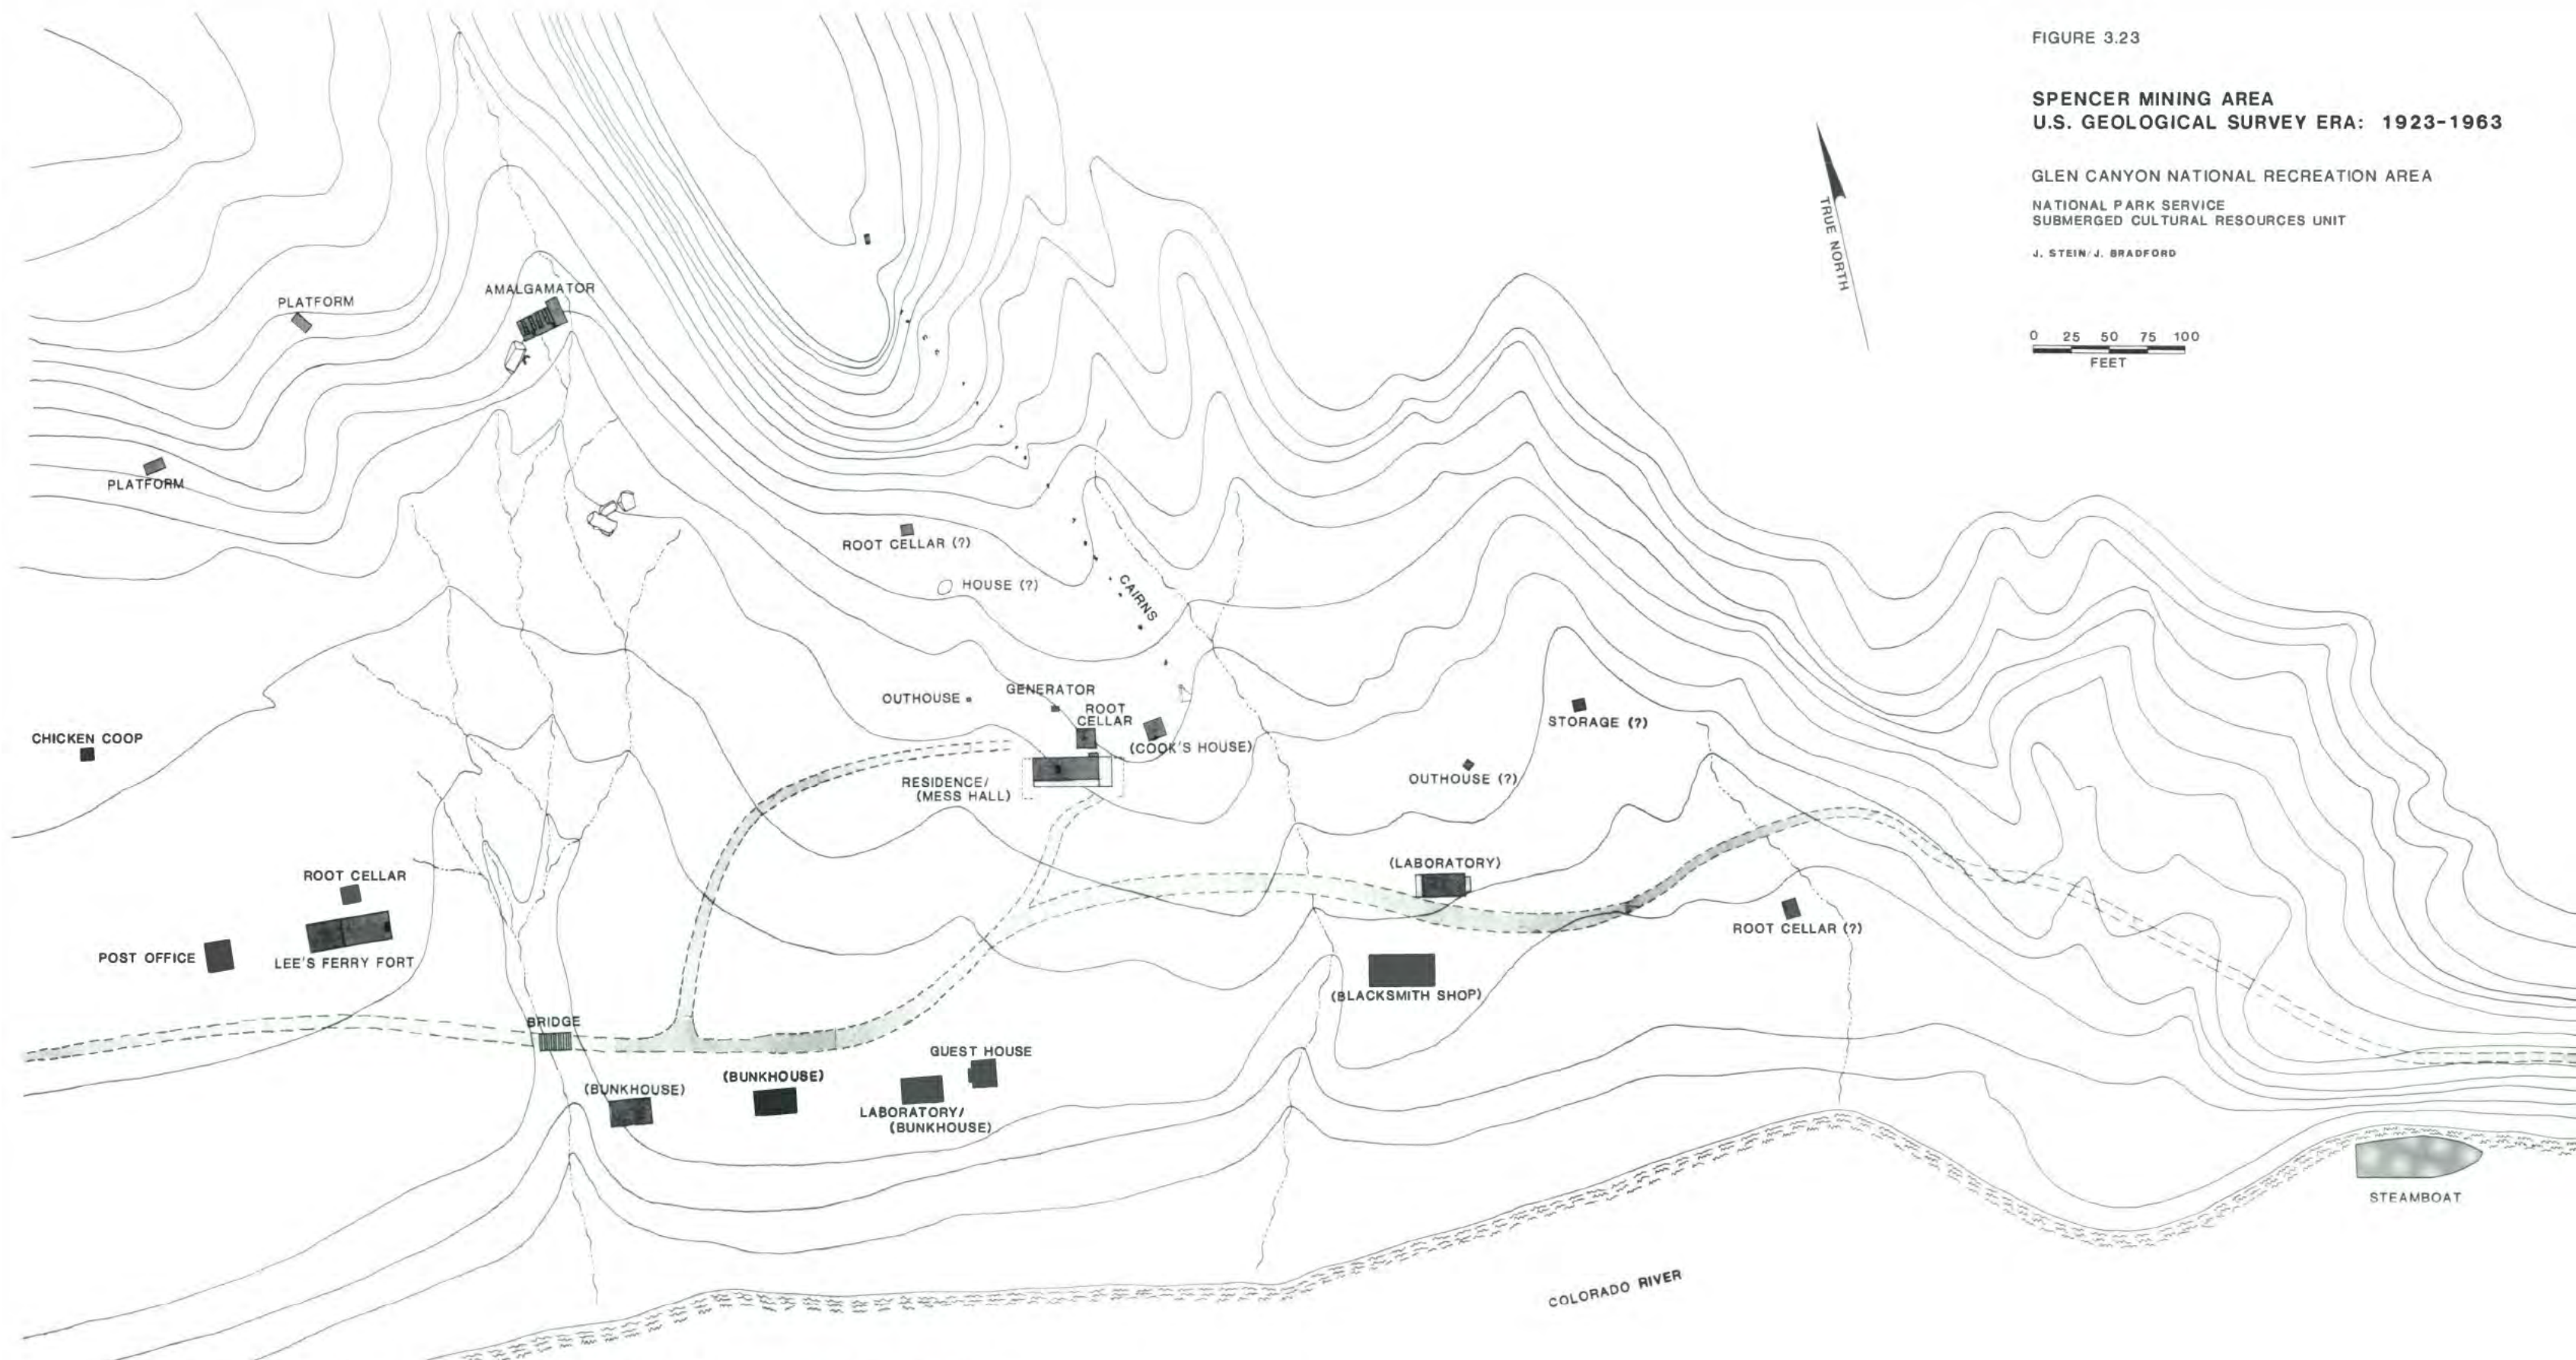
Figure 3.23. Map of the historic district as it appeared about 1963 at the end of the USGS era. Note the differences in the building configurations as compared to Figure 3.12.

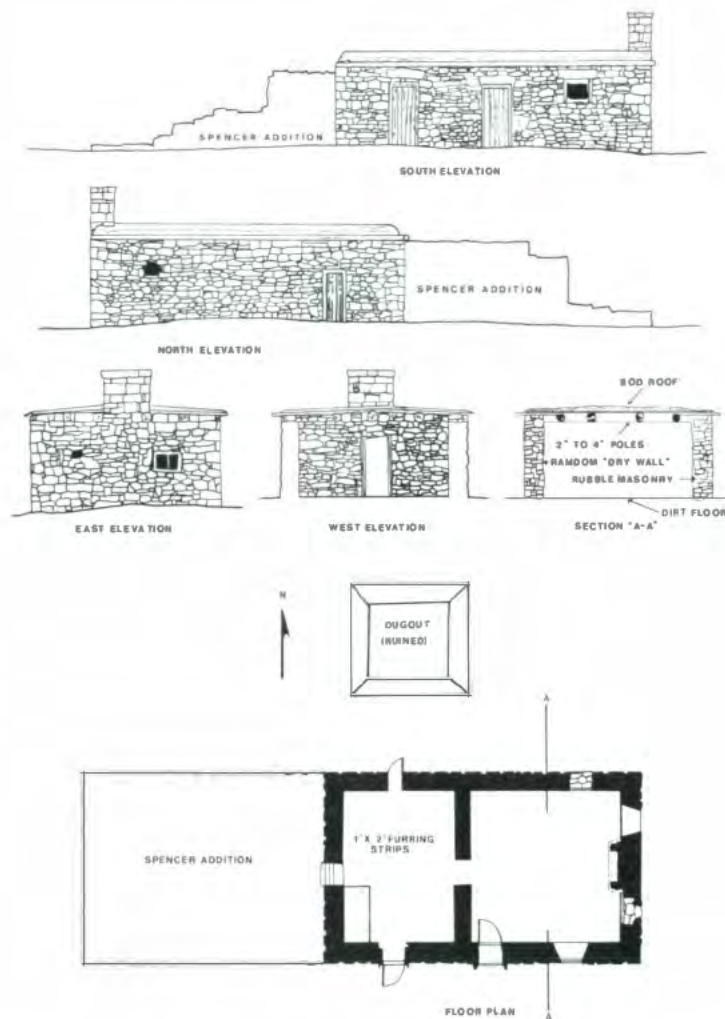
Figure 3.30. Plan and elevation drawings of Lee's Ferry Fort and the dugout immediately behind it. Adapted from Historic American Buildings Survey records.

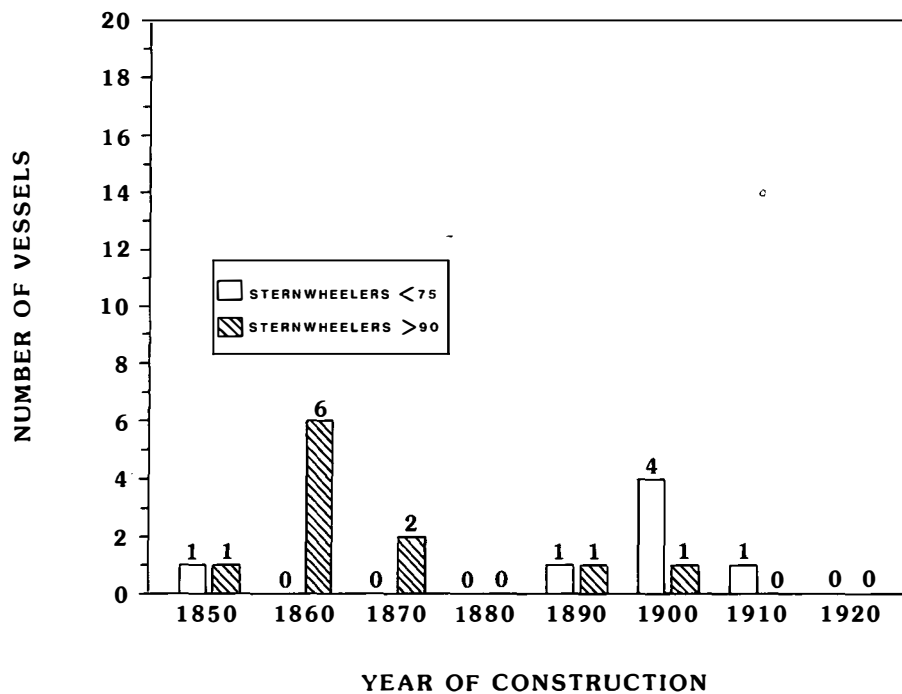
Figure 5.7. Comparison of steam-powered sternwheelers by size and year of construction.

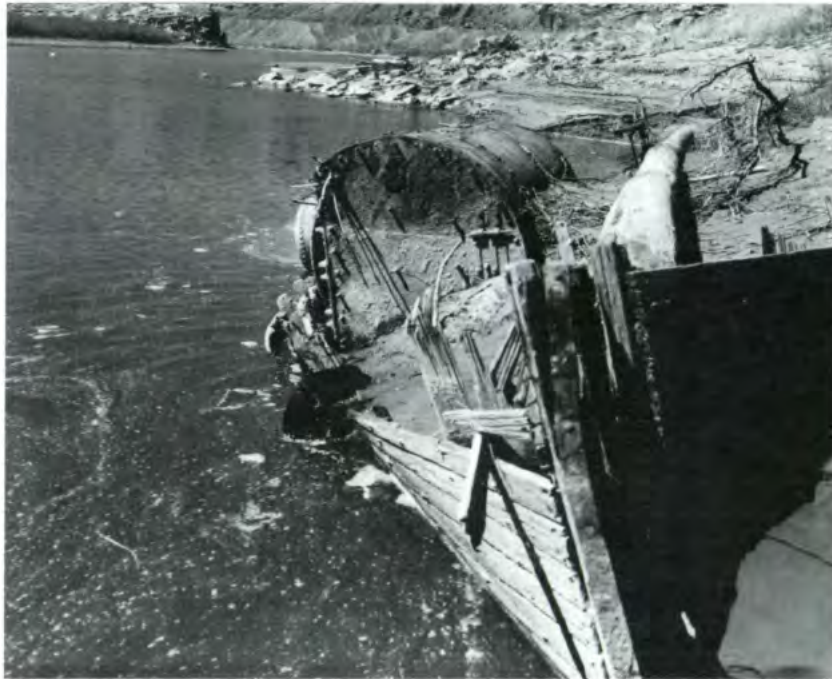
Figure 6.5 The bow of CHARLES H. SPENCER had deteriorated considerably by 1963. The small hand pump is still in place, however the boiler had rolled over onto the starboard side. Photo by W. L. Rusho.

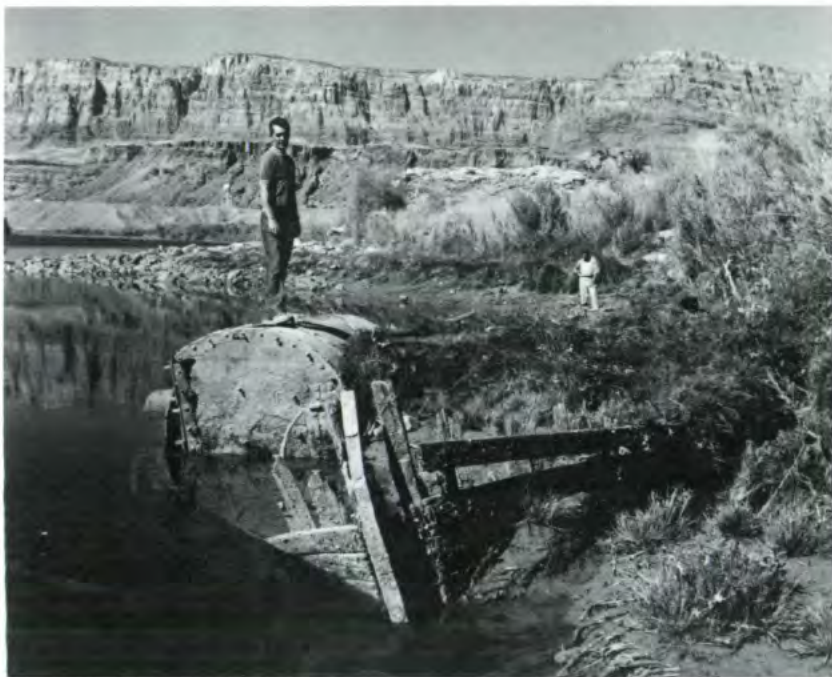
Figure 6.6 Ten years later, in 1973, the vessel was photographed from the same angle. Increased deterioration of the remains and extensive vegetative growth typified the site. Photo by W. L. Rusho

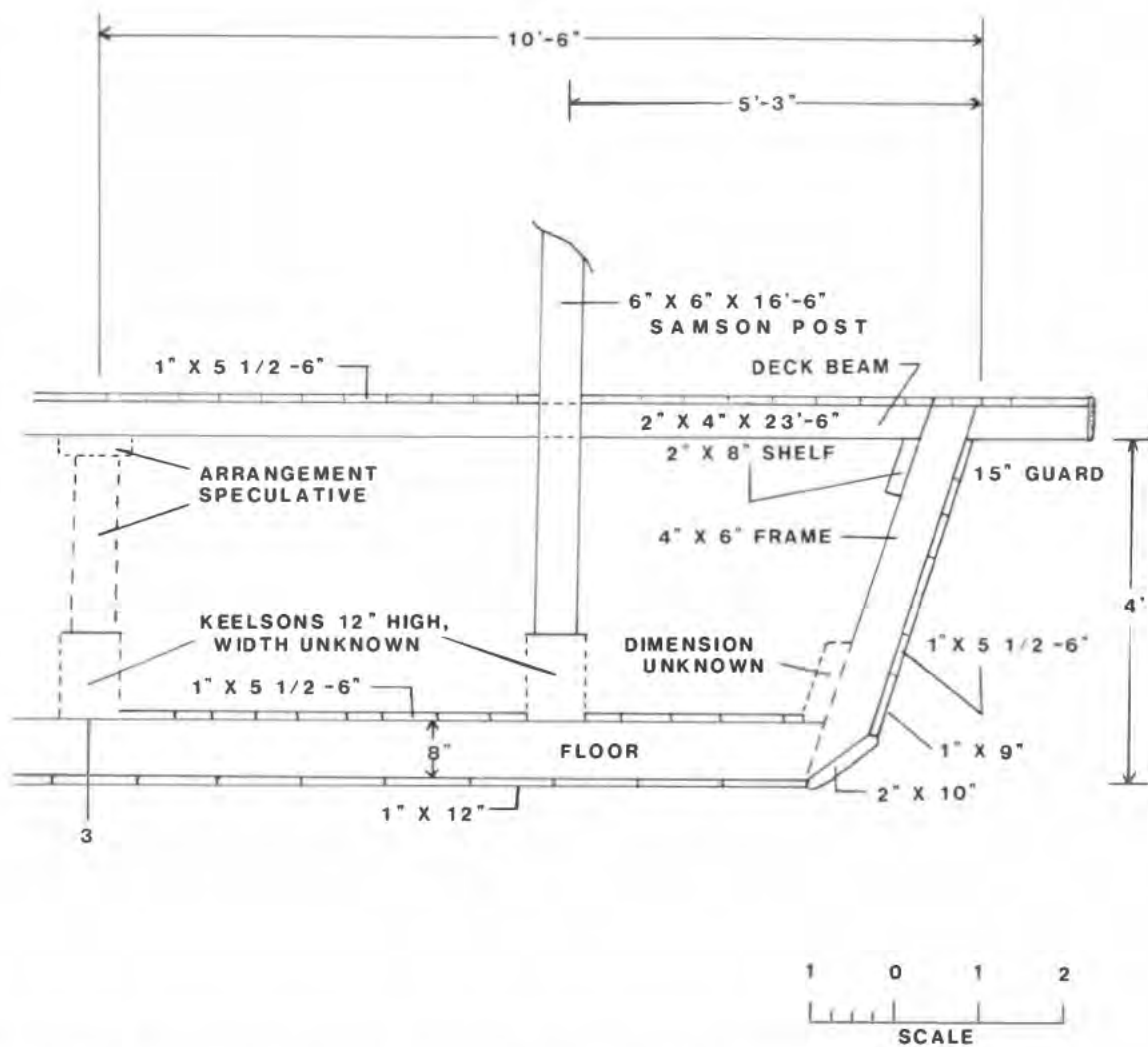
Figure 7.3 Hull cross-section, approximately amidships. View from stern.

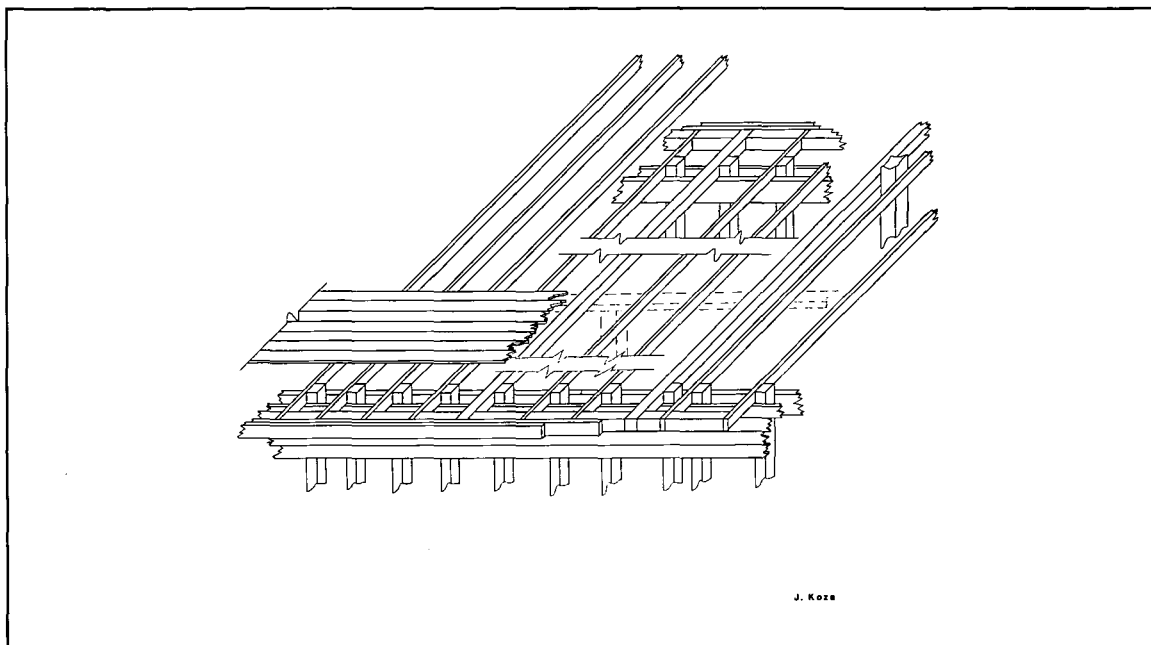
Figure 7.4 Exploded view of main deck construction.

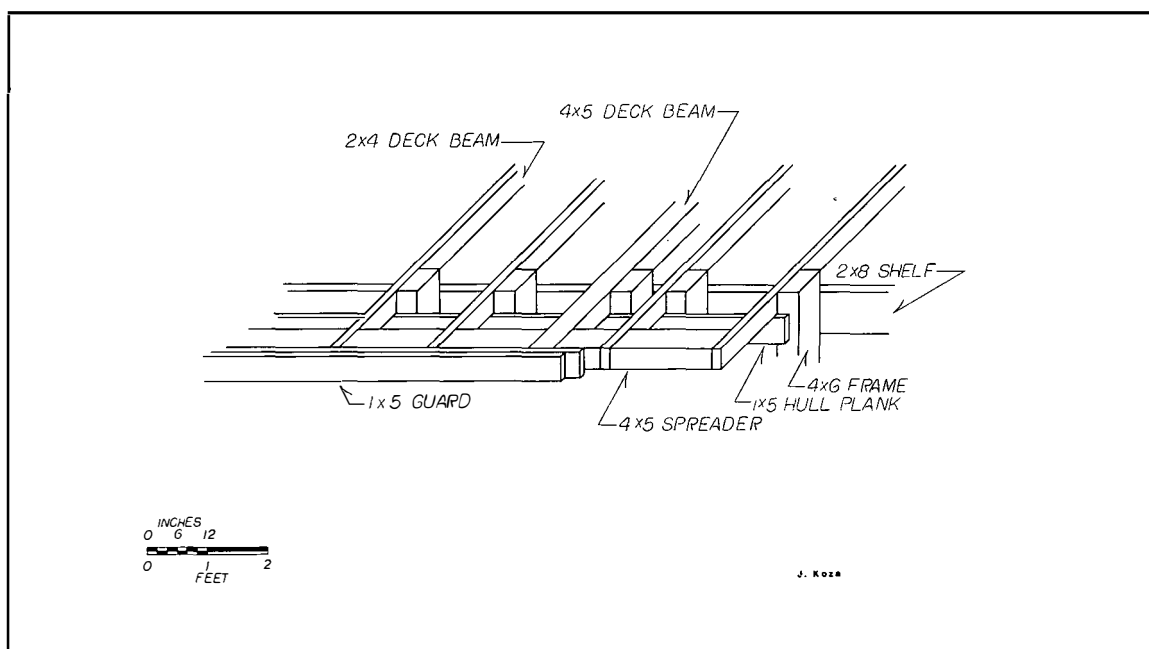
Figure 7.5 Detail of overhanging guard construction, approximately amidships.

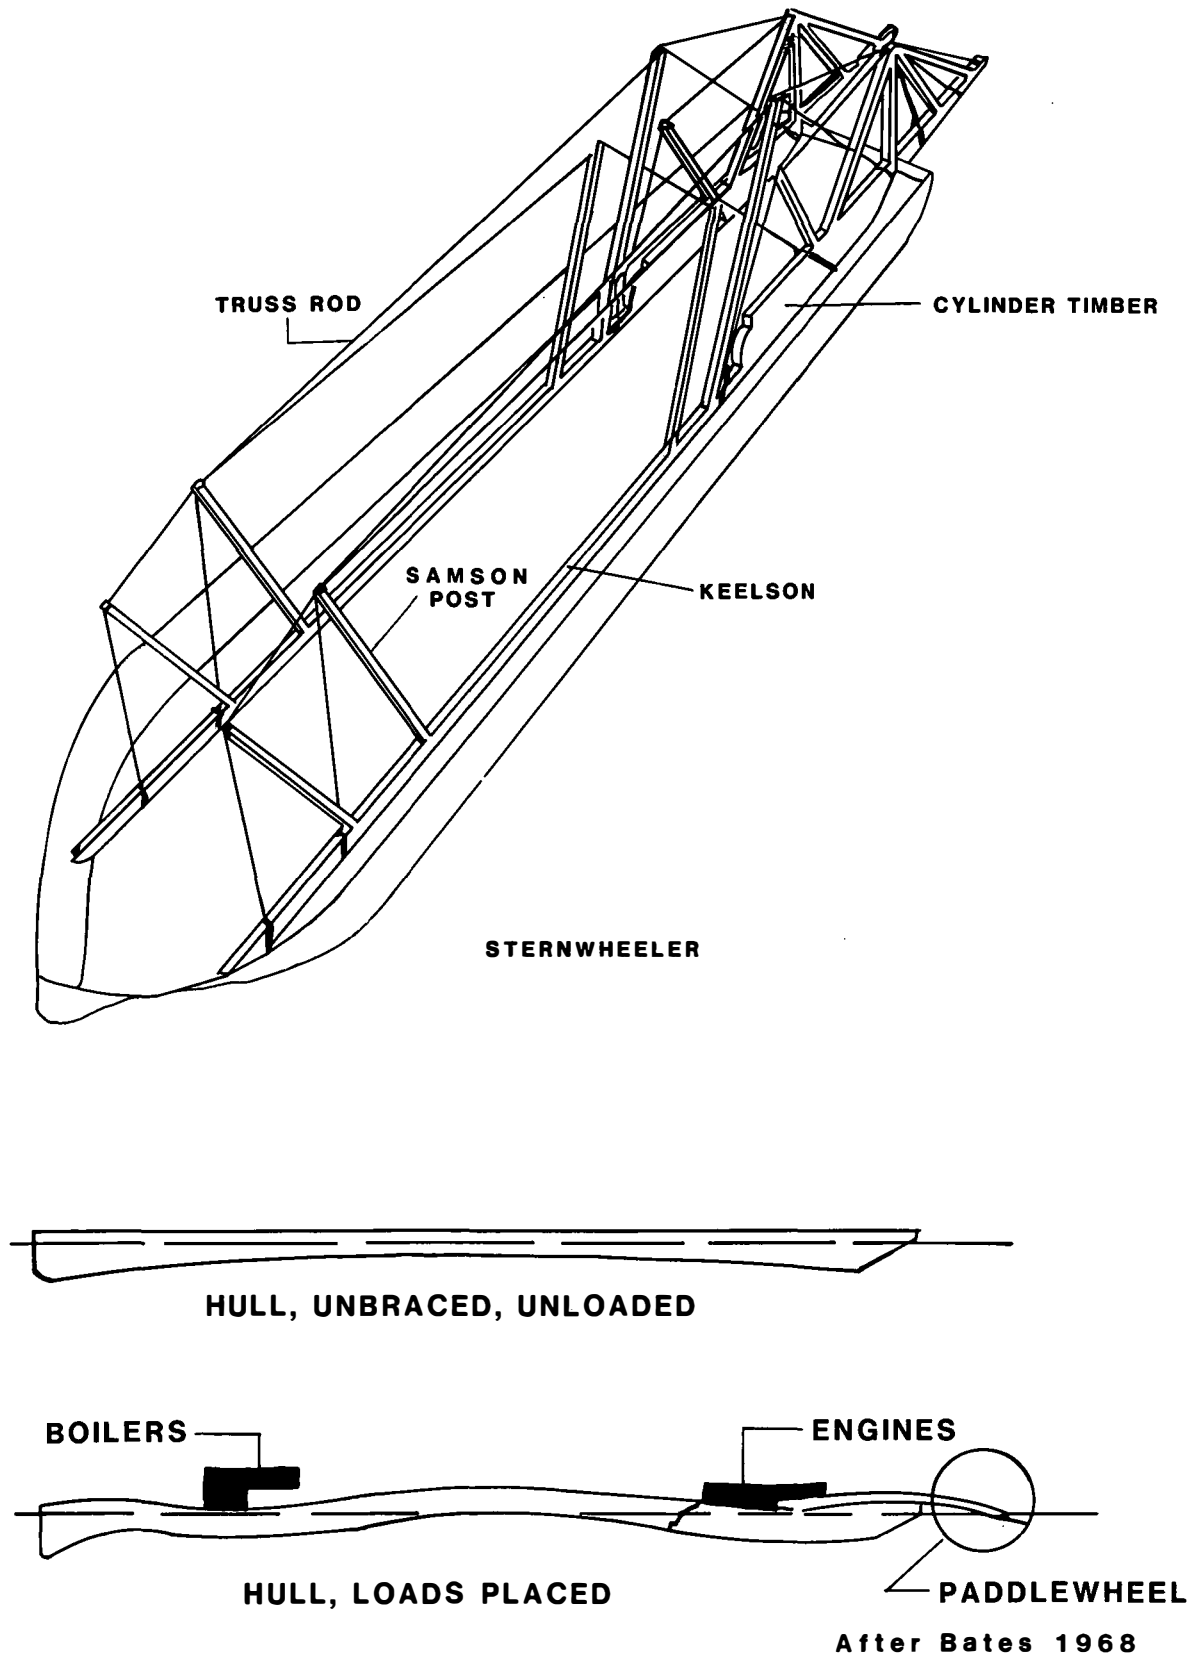
Figure 7.9 Typical arrangement of keelsons, cylinder timbers, samson posts, and truss rod on a stern paddle wheel boat and hull stresses as a result of boiler and engine loads.
